CONVERTING TO DETACHABLE INNER BUMPER AND FENDERS.

By Benson Murithi. 20th October, 2013.

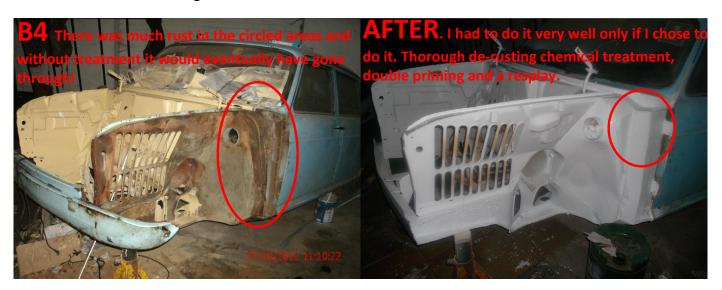
Rust in the circled area could someday open up to you right inside the cabin, especially in the circled area of the "after Photograph"! All washing and rain water from the windscreen area washes down this area through duct which could be most likely blocked by "cavity build up" and particles of all sorts.

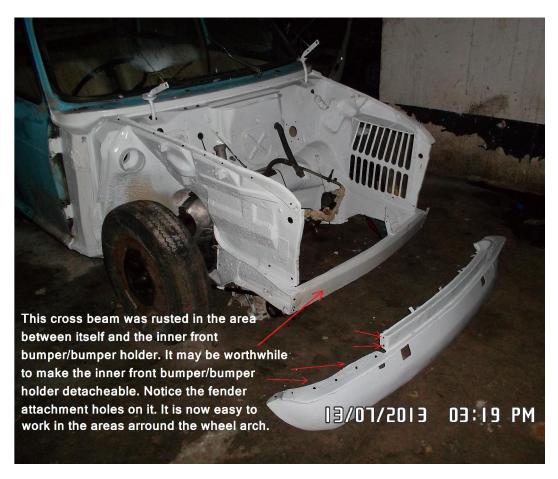
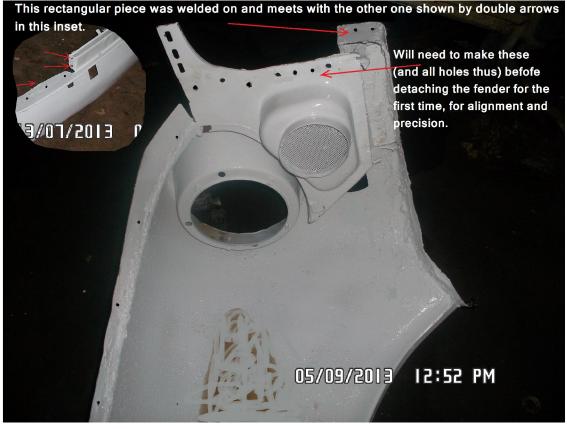
See how accessible the front end is without the fenders.....

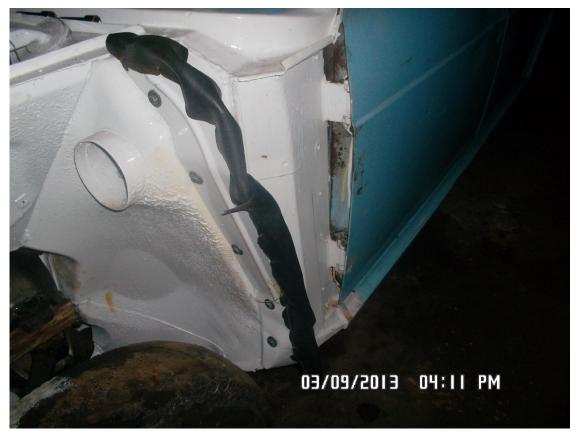
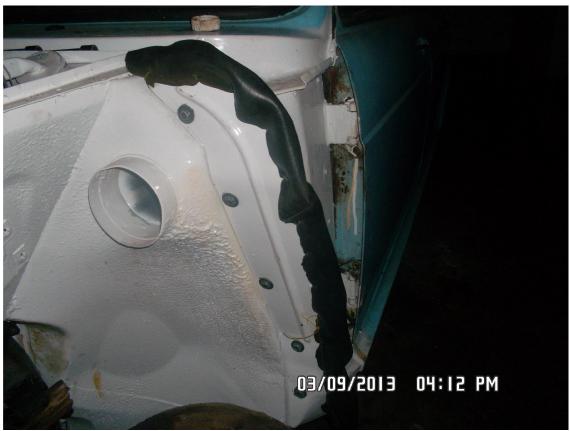
Inner mud guard and the normally concealed areas repaired (de-rusted and resprayed).

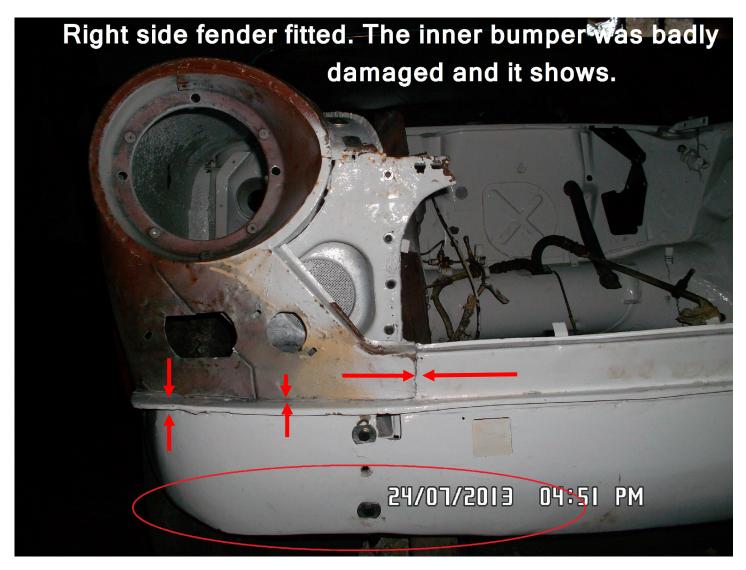
Fender fits tightly and in position...

This right hand fender is a replacement. Evidently the car had a smash on this front end, denting the fender and the inner bumper. Repairs undertaken were poor resulting in rusting of the panels. It is difficult to repair these panels in their permanently welded state! The task of making them detachable may mean we can have more Landcrabs on the road, at any time.

Now I can remove the fenders and do a thorough job on them. I will also rectify the inner bumper.
