# “Automatic Gearbox Overhaul”

An article by Tony Cripps

## **AUTOMATIC GEARBOX OVERHAUL – PART 1**

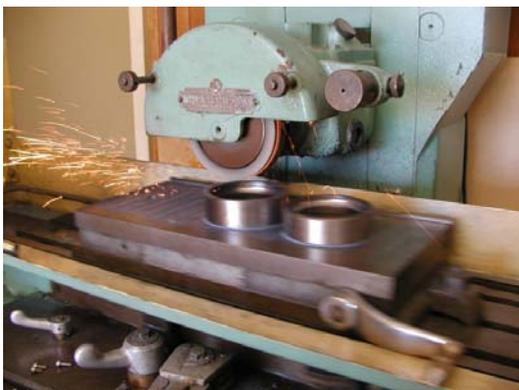
Of course, this bearing was not available anywhere in Australia and I soon became very familiar with all the bearing houses in the country. It was a Ransom and Marles bearing, quite a well known company in their day, and to my surprise, they still had a web site in UK. I found out later that R&M actually went out of business with the "R" side going to RHP. This place in UK appeared genuine enough, and even had the bearing in stock, but at an eye-watering \$350. The outer ring of this bearing is about an inch wide. During my investigations, I found a very good bearing supplier in Yennora (Sydney) who had a very similar bearing but the outer ring was about 5 mm thicker. Everything else was the same except for this thickness, and he only wanted \$75 for it. I paid the \$75 before he could change his mind, and said to myself I would make it fit somehow. I had visions of machining out the gearbox case so that the extra thickness would be accommodated, and all sorts of other ideas, until I thought the best thing would be if the bearing could be made to the right size. So, what I did was to take apart the new bearing so I was left with the outer ring, and then got the outer ring from the old bearing, and put them both on the magnetic bed of my trusty Jones and Shipman surface grinder. I then sat there for about an hour, taking off about 5 thou at a time, until I had ground down the new ring to the exact same size as the old. I used plenty of coolant to keep the temperature down, and smoothed off the sharp edge a little at the end. You can see the situation in the picture here. The left hand thicker ring had to be ground down to the same height as the one on the right.

Well, this actually worked really well. When I assembled the new bearing back, it fitted perfectly.
